PROCEDURE TO ADJUST THE DIRECTION CONTROL ARM

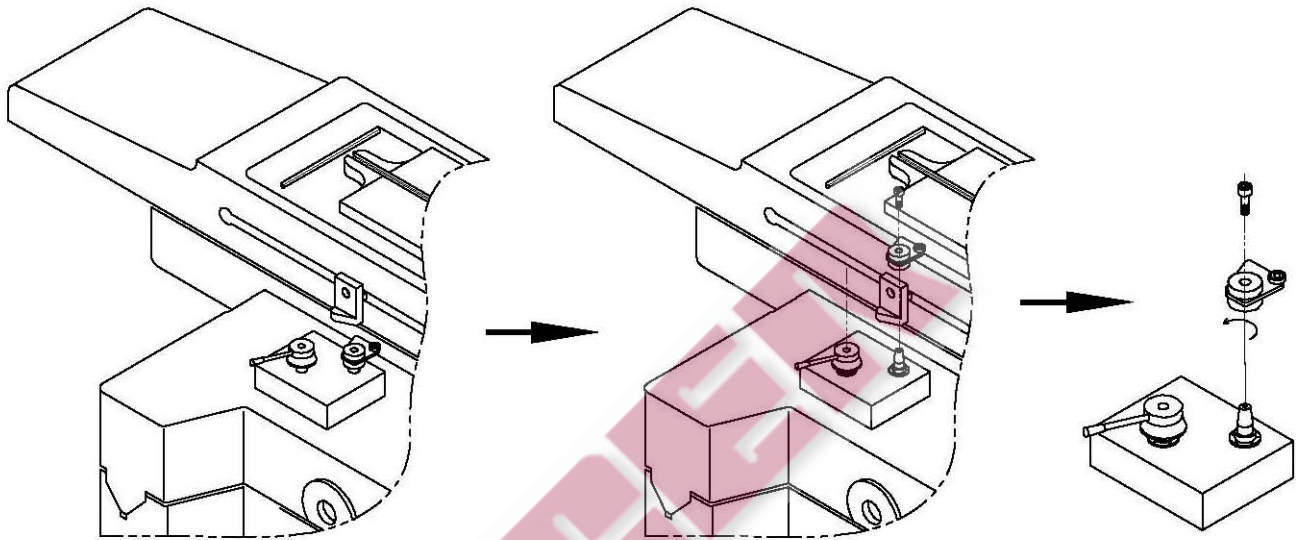
Problem: Table speed, one side normal, other side slow (uneven speed)

Cause: Direction Control Arm is off position

Step 1. Move table manually to slow side. Move table automatically slowly until the Dog touches the Direction Control Arm. Stop table right away (when table try to reverse). Make a mark on the Direction Control Arm position.

Step 2. Loose the hex nut screw on top of Direction Control Arm.

Step 3. Use a piece of block and wrench underneath of the Direction Control Arm to pop the Direction Control Arm up. Make sure the Direction Control Arm and shaft position are not moving, (Pop the Direction Control Arm straight up).

Step 4. Turn the Direction Control Arm counterclockwise a little bit, then tighten down the hex nut screw when table movement slow on left hand side. Vice versa (turn clockwise on right hand side).

Step 5. Use trial and error if need to do 2 or 3 times with the same steps.
